# Manhole Inspection Summary

Manhole # S25YY\_074MH

**Location** Address: **3300 CLIPPER RD**

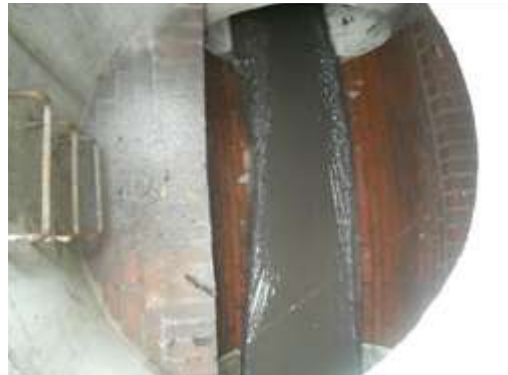
Top View

Bench debris.

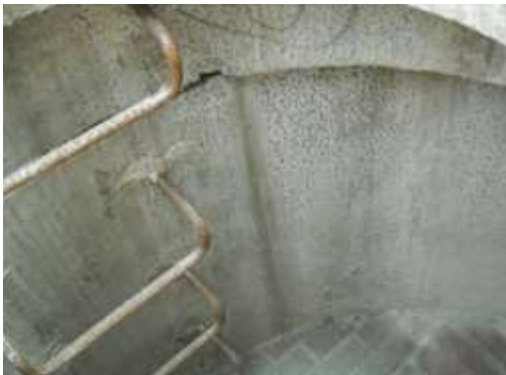
Defect

Infiltration: ☐ None ☒ **Joint** ☐ Cracks ☐ Mortar ☐ Roots ☐ Wall

Barrel infiltration.

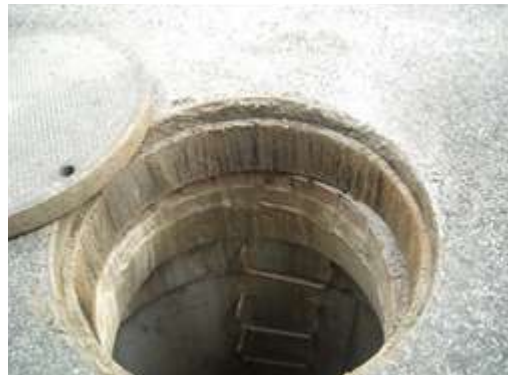
Defect

**Frame** Offset: **1** (in.) Condition: ☐ Sound ☐ Cracked ☒ **Leaks**

Infiltration: ☐ None ☒ **Joint** ☐ Cracks ☒ **Mortar** ☐ Roots ☐ Wall

Frame leaks. Adjustment and Barrel infiltration.

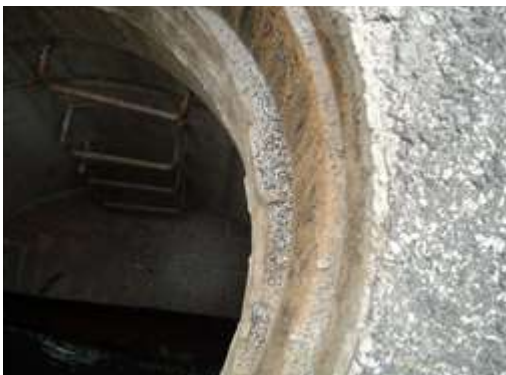
Defect

Frame leaks. Frame offset. Adjustment infiltration.

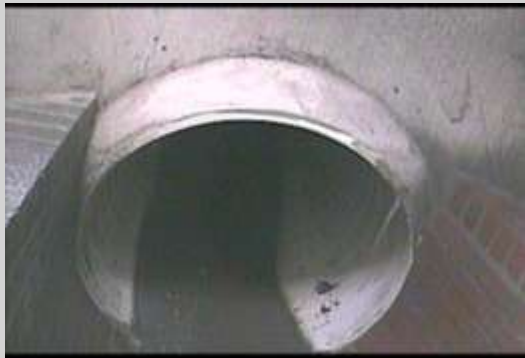
### 36 in. Circular Gravity Sewer Pipe Out @ 12 O'Clock

Infiltration: **Evidence** Pipe Seal Cond: **Roots**

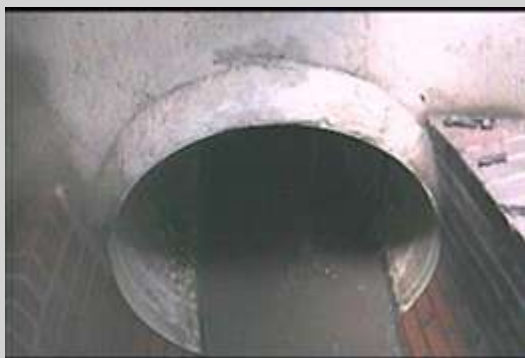
### 36 in. Circular Gravity Sewer Pipe In @ 6 O'Clock

Infiltration: **Evidence** Pipe Seal Cond: **Unknown**
